To What Extent Can a Grade II* Listed Building Be Converted into Energy-Efficient Eco-home

Emily Shaw¹, Mawada Abdellatif^{1*}, Yassin Osman², Denise Lee¹

¹Faculty of Engineering and Technology, Civil Engineering and Built Environment, Liverpool John Moores University, Liverpool, L3 3AF, UK

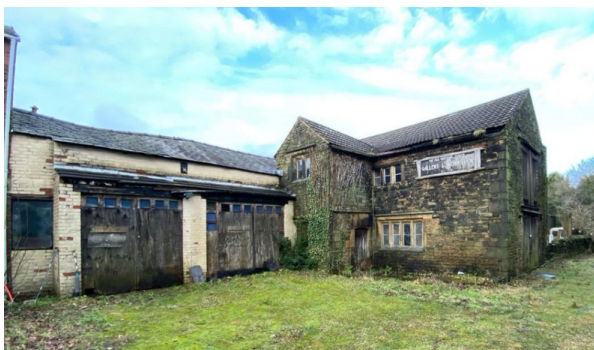
The building is generally in poor condition, has been used as a workshop most recently, and has not been maintained for a number of years (**Figure 1**). The windows do not open, and the building is heated by four open fires. The building is constructed from sandstone and timber, with an obvious lack of insulation. Hence, the building doesn't have typical hygrothermal properties, so these have been obtained from another building that has the same size and construction. The sandstone blocks are weathered and need repointing. Data was collected via a hygrometer and through the use of a thermal imaging camera. These results were then used to calibrate a model using IESVE software. The Old Grammar School in its current state is shown in (**Figure 1**) below.

Figure 1: The Old Grammar School 2021

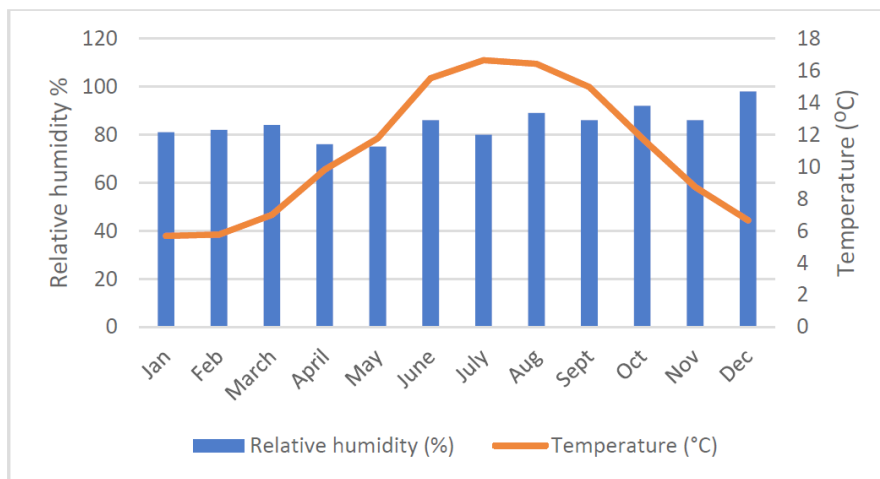
To ensure the consistency of environmental conditions and since the property is not in use, the thermal models considered Liverpool John Lennon weather station (UK) for purpose of the simulation. The weather file contains 12 typical meteorological months composed of hourly weather data records. Datasets with the purpose of predicting the average heating. (Figure 2) shows the average monthly outdoor air dry-bulb temperatures along with relative humidity (RH). It is evident that the studied site experiences temperature fluctuations that range from 16°C in summer to 5°C in winter, while RH ranges from 75% to 98%.

Figure 2. Monthly outdoor air dry-bulb temperature and relative humidity

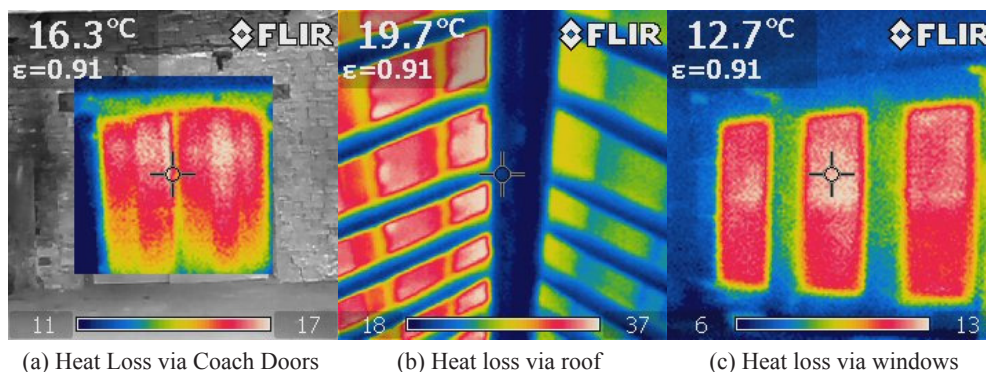
Figure 3. Thermal Imaging Results

(Figure 3a) shows heat loss via coach doors situated on the first floor, however there is a second set of the same doors situated directly below, on the ground floor. The doors are made from timber which is in poor condition, and they have been covered in carpet on the inside, in a bid to offer a form of insulation from draughts. **(Figure 3a)** shows the poor fabric condition of the doors. These doors are 2.4m wide by 2.2m, hence this is a large area of heat loss. In addition to this, these doors are also a source of airflow due to their poor condition and the fact that they are poorly fitted, both of which cause a draught.

(Figure 3b) shows heat loss through the roof, this image confirms the lack of insulation in the building. The right-hand side of the roof is colder than the left side, indicated by the green colour for the cooler temperature and red to show the warmer temperature. The sun was incident on the left side of the roof, which accounts for the temperature difference between the left and right sides of the roof. Due to the phenomenon of heat rising coupled with the large area of the roof (when compared to the total area of the building) this is a large heat sink. Significantly, the highest temperature

recorded in the whole building was through the roof, from the inside of the building.

Similarly, the windows in The Old Grammar School are allowing a lot of heat to escape through them. This is mainly due to the single glazing used in all the windows; the problem is exacerbated due to the poor condition of the glass and sandstone mullions. **(Figure 3c)** shows the heat loss through the glass, in addition to heat loss through the surrounding sandstone mullion, which is in poor visible condition as the sandstone can be seen to be crumbling.

The main sources of heat loss identified via infrared imaging are through the roof and windows, and since their collective area is so large, they can be said to be areas of particular concern. The windows are extremely old and are made of single panes of glass. Additionally, in most areas of the building, the glass is not securely bonded to the stone mullion surround. The roof is also a cause for concern, given that

there is no insulation present, which is unheard of in buildings constructed today. Another main source of heat loss is via some coach doors, of which there are two sets, one set on the ground floor, and another set directly above these, on the first floor. These doors are large and are visibly in poor condition, which was confirmed using thermal imaging. The doors have been covered with carpet on the inside, to insulate them to some extent. **(Figure 3)** shows the results of the thermal imaging assessment, detailing the areas of concern identified.

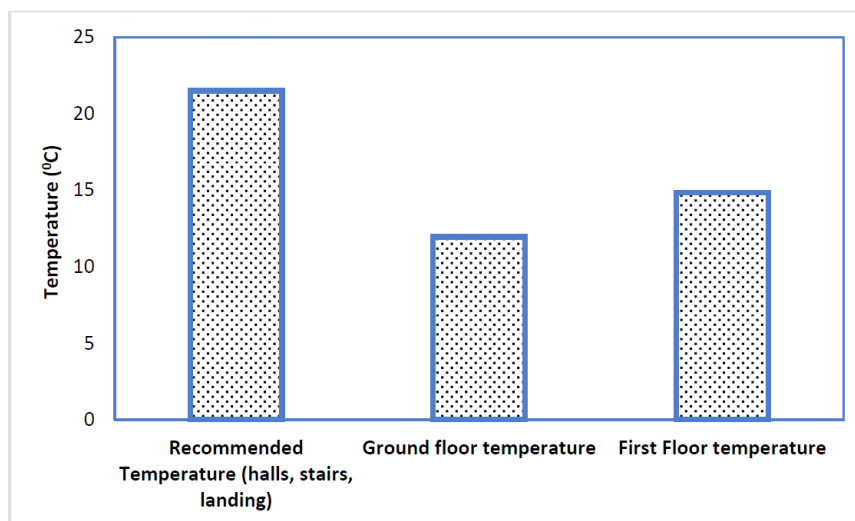
Figure 4. A graph of the comparison of recorded temperatures Vs those recommended in CIBSE Guide A

It is clear from this graph in (Figure 4) that the temperature inside The Old Grammar School is significantly lower than the recommended

temperature outlined in CIBSE Guide A. There is a particular concern with regards to the ground floor as temperatures here are much cooler than the first

floor, yet the temperature on both floors falls short of the recommended temperature. These results are to be expected given that no insulation at all is present in the building, in addition to no heating system. Sandstone blocks are the main building fabric, and they are in very poor condition and can be seen to be visually crumbling. The mortar between blocks needs to be replaced and there are numerous inlets between the blocks. This means air and water can easily enter the building, hence keeping it cool. The first floor is of a higher temperature due to the phenomena of convection, and as a result warmer air rises. As the roof is not insulated, it absorbs heat during the day and hence the first floor is heated this way. Evidence of this is provided in the thermal imaging results, where the roof can be seen to be two different temperatures, with the side that is facing the sun having a higher temperature than the opposing side of the roof, which was shaded from the sun at the time of inspection.

These results have been compared with the (Table 1.5) of CIBSE Guide A shown in Appendix A which is the recommended comfort level of specific applications^[10]. As the current configuration of the building has no partitions and is just an open space segregated only by the floor divide between the ground and first floor, it has been decided that each floor will be compared with the recommended temperature for hall, stairs, and landings. This is because these areas are generally open spaces, which is the closest option that best represents the current space at The Old Grammar School. The recommended target temperature to achieve the comfort level according to CIBSE Guide A for halls, stairs, and landings is provided as a range of 19–24 °C; the average value of this has been chosen for purpose of the comparison, which is 21.5°C. It is worth noting that the recommended temperature of halls, stairs and landings is lower than the recommended temperature for all other rooms in the home, such as bedrooms.

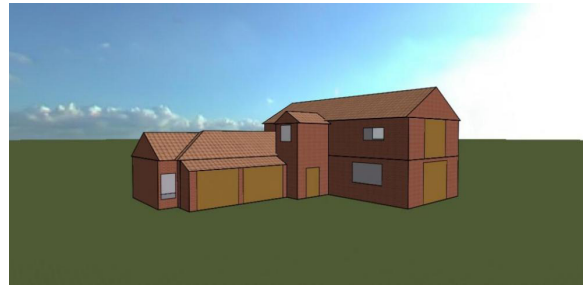
habitable space. Hence the results of the baseline model should be compared with other models with caution. (Figure 5) shows 3D view of the baseline model of the building created with IESVE.

Figure 5. 3D view of the baseline model in IESVE

The options chosen for the creation of the baseline model are as highlighted under the experimental approach section. The use of ApacheSim (dynamic simulation) within IESVE generates a variety of model outputs. Outputs deemed significant for the baseline model include total system energy, carbon emissions, solar azimuth, and wind speed.

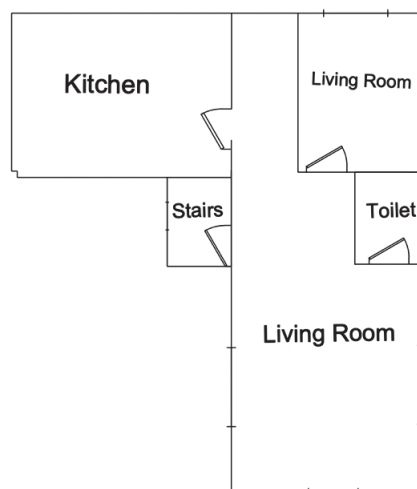
The layout of the building was restricted as the partitioning required to create rooms could only be devised around existing windows and door frames, to keep the changes as minimal as possible due to the listing status. The layout chosen provides three bedrooms, a bathroom and downstairs toilet, as well as two living rooms and a kitchen. A plan of the ground floor is shown in (Figure 6), whereas the first-floor plan is shown in (Figure 7).

Figure 6. Proposed ground floor plan

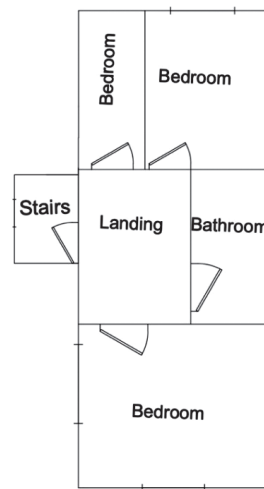
Figure 7. Proposed first floor plan

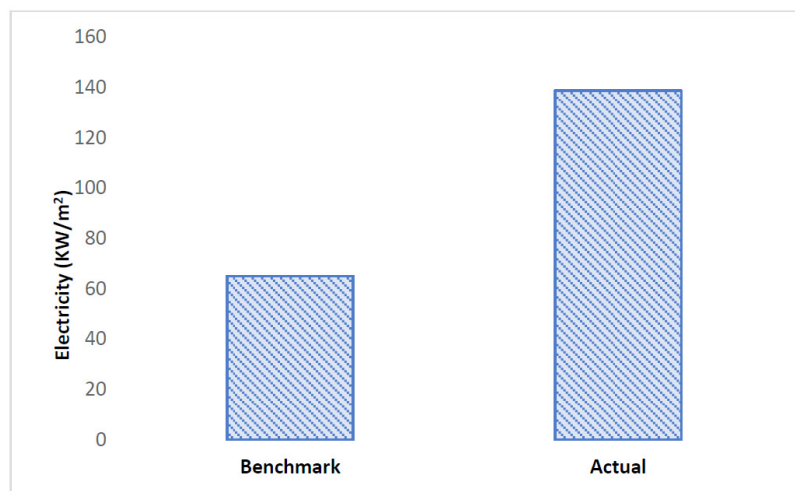
the building. Electricity usage is above the benchmark but as previously discussed, this is expected due to the use of renewable energy to heat the house, and to compensate for the lack of gas usage. As the final proposed design performs better than the benchmark on two out of the three criteria, that is carbon emissions, electricity usage and gas, then the proposed design is considered to be eco-friendly. (**Figure 8**) shows the electricity usage from the final design (model 6) compared to the benchmark.

Figure 8. A bar chart comparing the actual electricity usage from model 6 compared to the benchmark

Electricity is above the benchmark as already outlined, yet this should not be a cause for concern. (**Figure 9**) shows the carbon emissions projected by

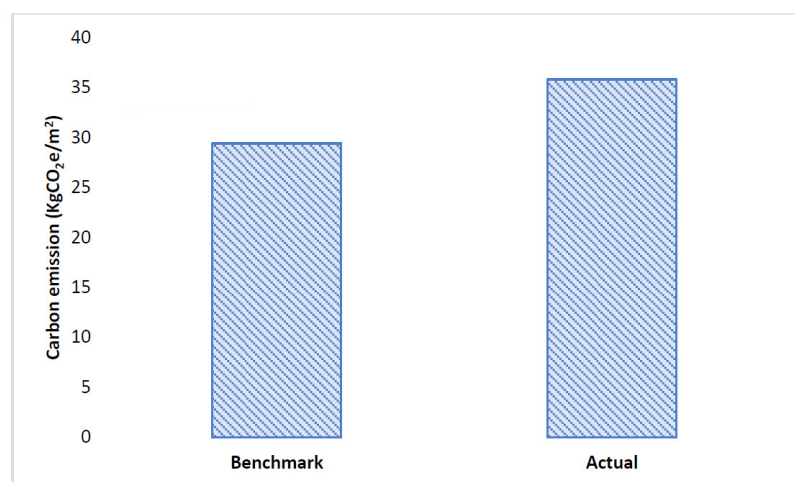
model 6, compared to the benchmark. As shown carbon emissions are almost 1/5 less than the benchmark, showing great savings in carbon emissions.

Figure 9. A bar chart showing the actual carbon emissions from model 6 compared to the benchmark
